# MIDDLE NORTH SERIES DIAL PACK EVENT

## PROJECT OFFICERS REPORT

PROJECT LN-318

## TEST OF PRECAST CONCRETE UNDERGROUND STRUCTURE (U)

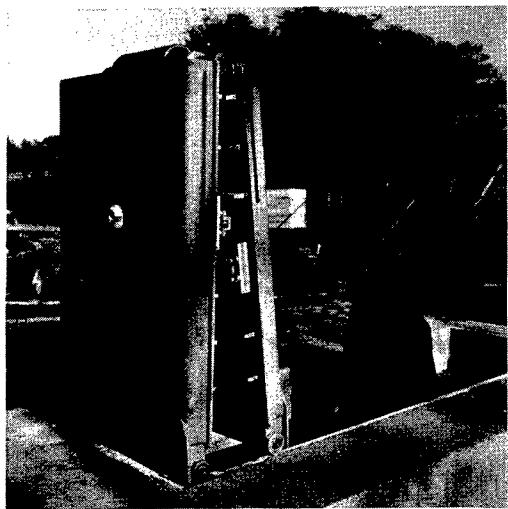
Figure 14. --Blast hatch used on SA Manhole.

Figure 19 shows a postshot view of the blast hatch. The hatch cover did not sustain damage and was still secured in place after the blast. The strain bolts, which had been preloaded to 1,000 pounds each, indicated very little rebound loading due to the blast. See table 1 for recorded measurements.

Although both the two-part folding blast hatch and the smaller one-piece cast-aluminum manhole cover survived the blast as installed, the low rebound forces recorded in the hold-down bolts of the blast hatch were unexpected. The rebound behavior of this blast hatch should be studied further.

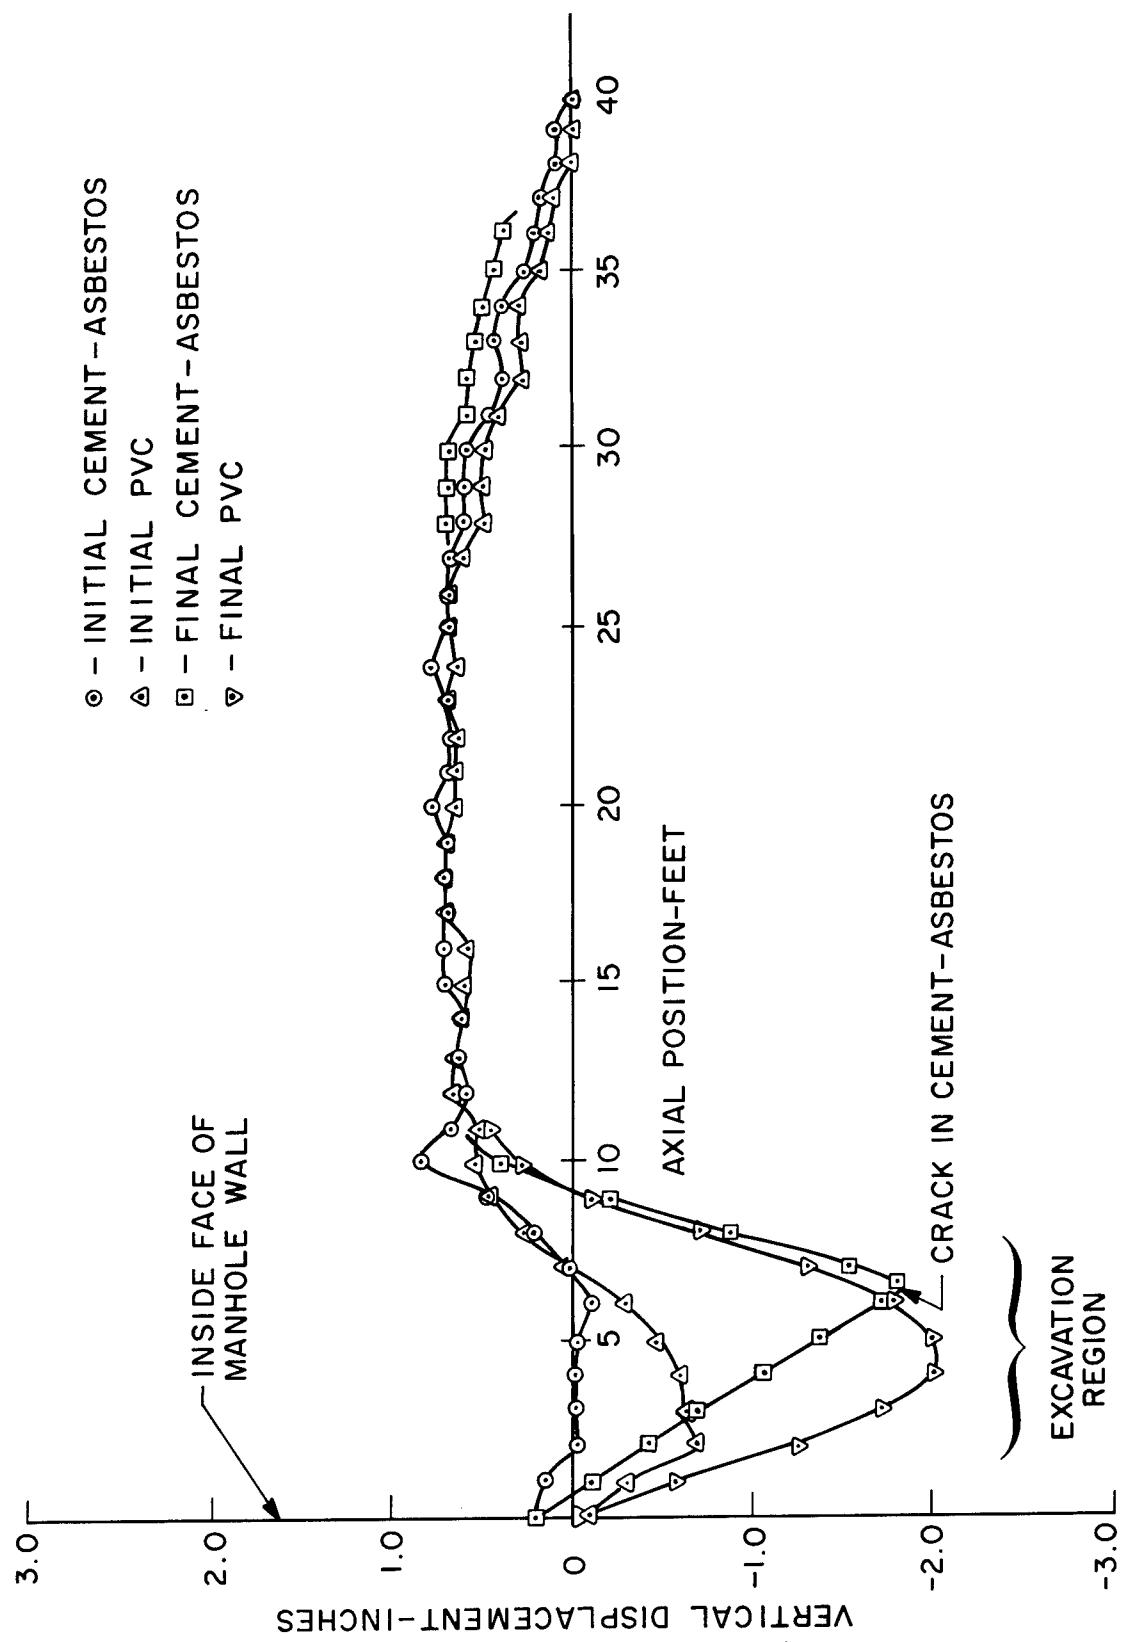
Figure 20. --Main conduit vertical axial deformations.

In figure 20 the vertical axial deformations of the main conduits are shown. It was found that there were virtually no changes in the configurations of the two conduits over the full length in the horizontal plane (not shown) and over all but the first 10 feet in the vertical plane. Not only did substantial vertical deformation changes occur in the excavation region due to the blast, but initial alignment there was much more irregular. A circumferential crack was noted in the cement-asbestos conduit about 6-1/2 feet from the inside end. Beyond the 10-foot position, any changes that might have occurred were generally small and less than the estimated 0.10-inch possible error inherent in the measuring method. From 28 to 36 feet out, the measured deformations differed slightly from the initial readings for the cement-asbestos conduit, but the changes were upward, a movement which would not be expected. Thus, the data there were considered suspect on initial investigation.
